**Flood Control Project Maintenance
Levee Inspections**
LMA District Cover Sheet
Spring 2009 Levee Inspection Results

Maintenance Area 0007

Levee Inspection Report By Mile - Spring 2009

Waterway						Bank	Unit Miles	Inspection Start/End	Inspector	
Unit No. 01 Feather River						Right	12.10	05/14/2009 05/14/2009	Clay Thomas

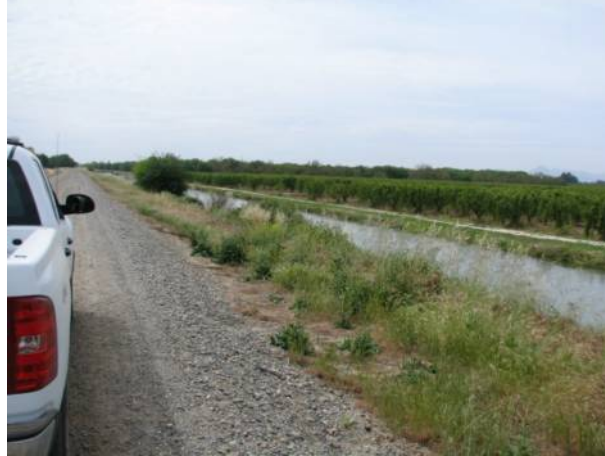
Levee Mile Report Line	1
Start Levee Mile	0.01
End Levee Mile	1.73
Location	Land Side
Category	Earthen Levee
Item	Encroachments

AG ditch land side slope and toe.

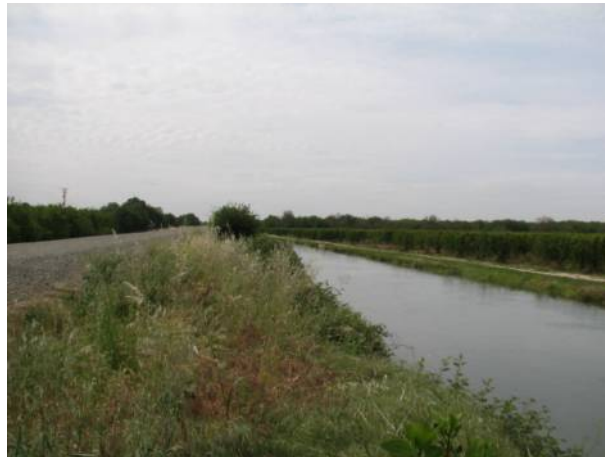
Levee Mile Report Line	14
Start Levee Mile	3.85
End Levee Mile	5.37
Location	Land Side
Category	Earthen Levee
Item	Encroachments

AG ditch land side slope and toe.
